## ExpertALERT™ Automated Diagnostics Performance

210 TON York Air Conditioning Chiller

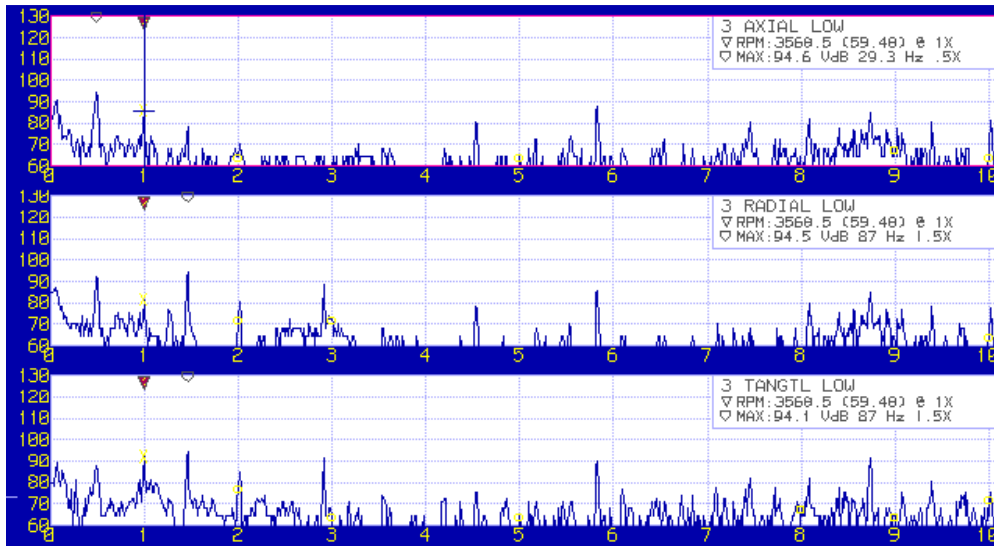
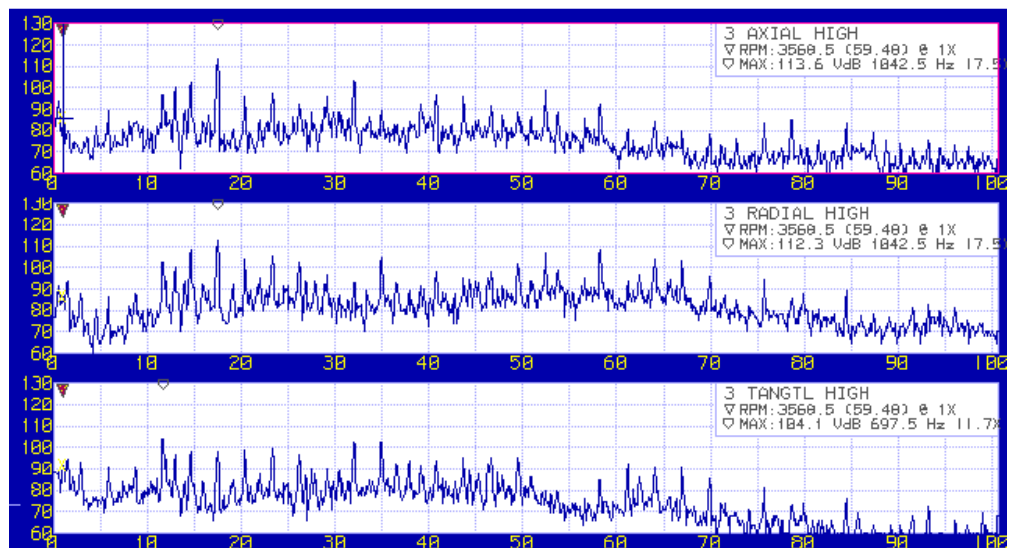
Journal bearing problems are difficult to diagnose. Unlike rolling-element contact bearings, there is no clear mechanism for generating specific vibration frequencies. As the sleeve bearing wears, the clearances increase. This increase in clearances often times causes a series of harmonics in the spectrum at the running speed. Manual analysis was also performed by an Azima DLI analyst to back up the EADS automated diagnostics, and found to be in agreement with the EADS report (see low and high range graphs below).

On September 22, three weeks after the data was collected, this unit failed. The chiller was disassembled by York technicians, and all internal compressor components were inspected. Among the findings were high speed journal and thrust bearing wear and the gears were badly corroded and damaged beyond repair. The cause of the bearing wear was determined to come from the pre-rotation vanes found to be partially open, thus causing the compressor to start under load.

SERIOUS COMPRESSOR JOURNAL BEARING WEAR  
 is indicated by 114 VdB [3A] at 6.00xC  
 112 VdB [3R] at 6.00xC  
 105 VdB [3R] at 8.00xC  
 107 VdB [3R] at 18.00xC  
 108 VdB [3R] at 20.00xC

PRIORITY MED: INSPECT COMPRESSOR BEARINGS FOR PROPER CLEARANCES  
 Maximum Level is: 114 (+ 7) VdB [3A] at 6.00xC
