## ExpertALERT™ Automated Diagnostics Performance

210 TON York Air Conditioning Chiller

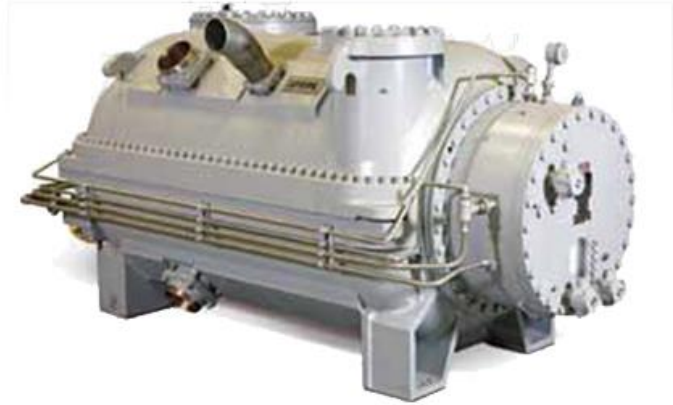
As part of a service agreement, York International was required to provide the University of Pennsylvania power plant with a vibration analysis survey on its 210 ton chiller. Azima DLI was chosen to perform this machine condition analysis by York. The chiller unit consisted of an AC motor, running at 3570 RPM, coupled to a speed increaser gear set with 41 pinion teeth turning the centrifugal compressor shaft at approximately 10,400 RPM. The compressor had 17 compressor vanes and was fitted with journal (sleeve) bearings.
